**LTPP Seasonal Monitoring  
Program**  
Site Monitoring Suspension  
Status Report  
Section 331001  
Concord, New Hampshire

# SEASONAL MONITORING PROGRAM SUSPENSION STATUS REPORT NEW HAMPSHIRE SECTION 331001

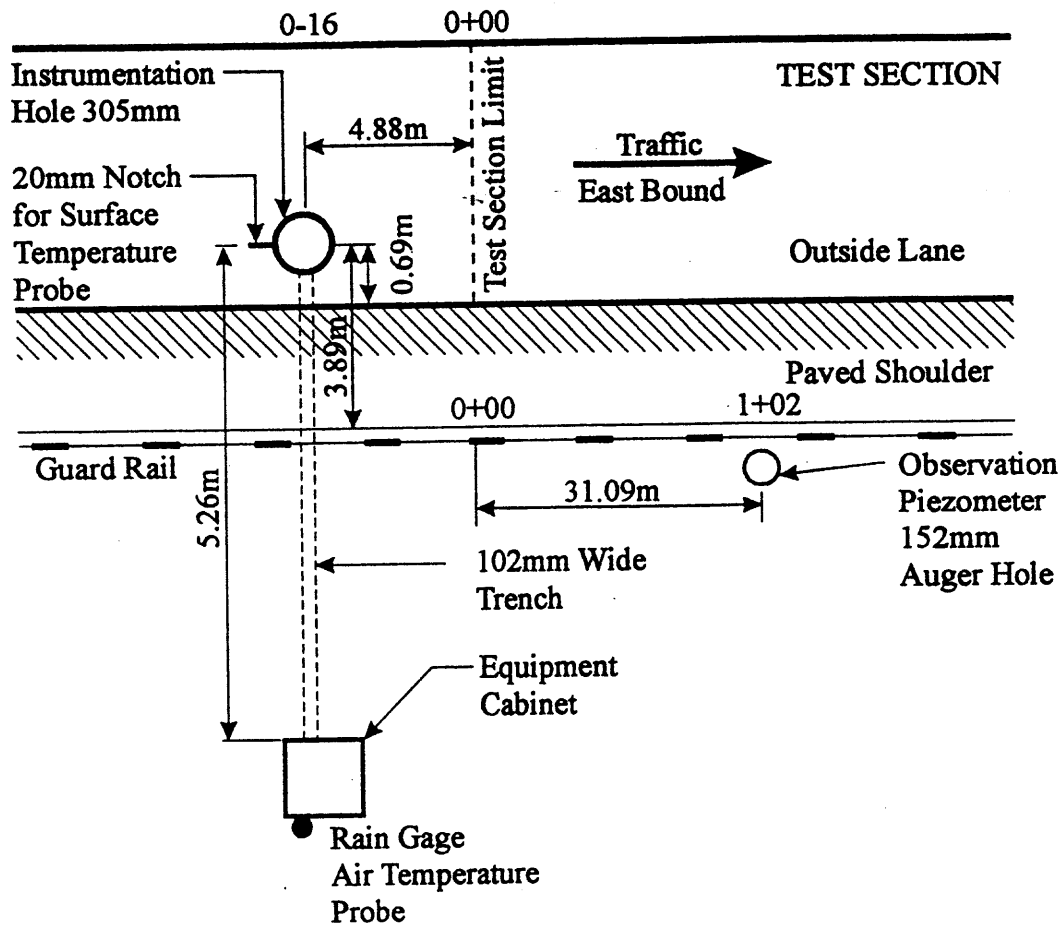
Figure 1. Location for Seasonal Monitoring Instrumentation Installed at GPS 331001

Figure 1 shows the locations of the installed instrumentation at the site. The instrumentation hole is at Station 0-16 and the piezometer is at Station 1+00. Table 2 gives the elevations of the portion of test section 331001 that was used for elevation measurements. All offsets are from the PK nails found at the outside pavement edge.

- Height of Air Temperature Probe (center): 3.07m
- Height of Tipping Bucket Rain Gage (center): 3.05m
- Total Depth of Piezometer: 4.29m
- Distance of Piezometer Below Ground Level: 152mm

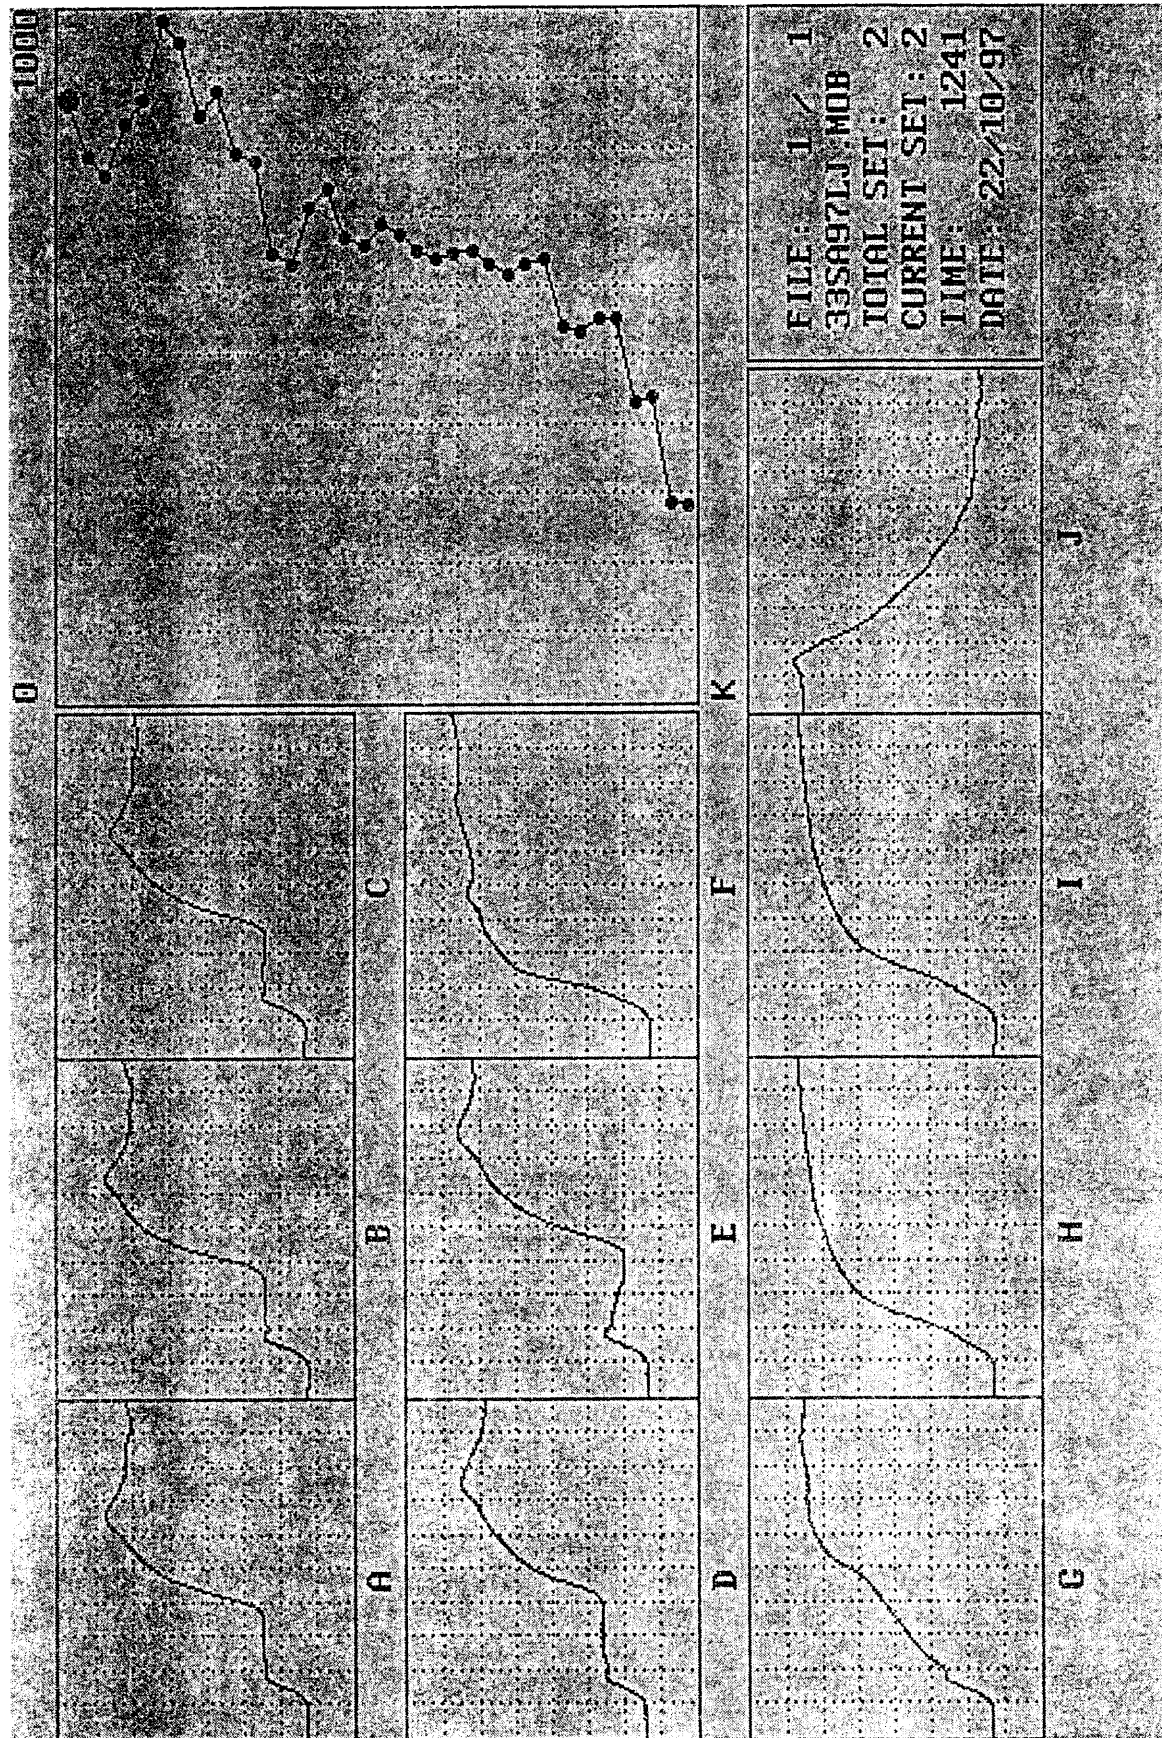
Figure 2: Second Set of Mobile Data Collected on October 22, 1997

At the time of suspension, MRC #1 sensor was not functioning. This sensor was not functioning at the time Round 2 data collection activities began in October 1996. Also, TDR sensors #6, 7, 8 and 9 were not functioning. TDR sensors #6 and #9 were not producing readable traces at the time Round 2 data collection began. A plot of the erroneous MRC #1 sensor is not provided because the temperature values are off a plotable scale. Figure 2 shows the last set of mobile data collected before the site was suspended. Other than the above, there were no unresolved problems with any of the sensors at the time of site suspension activities. The plots from ONSFIELD, MOBFIELD and SMPCHECK follow expected trends and produce expected values.

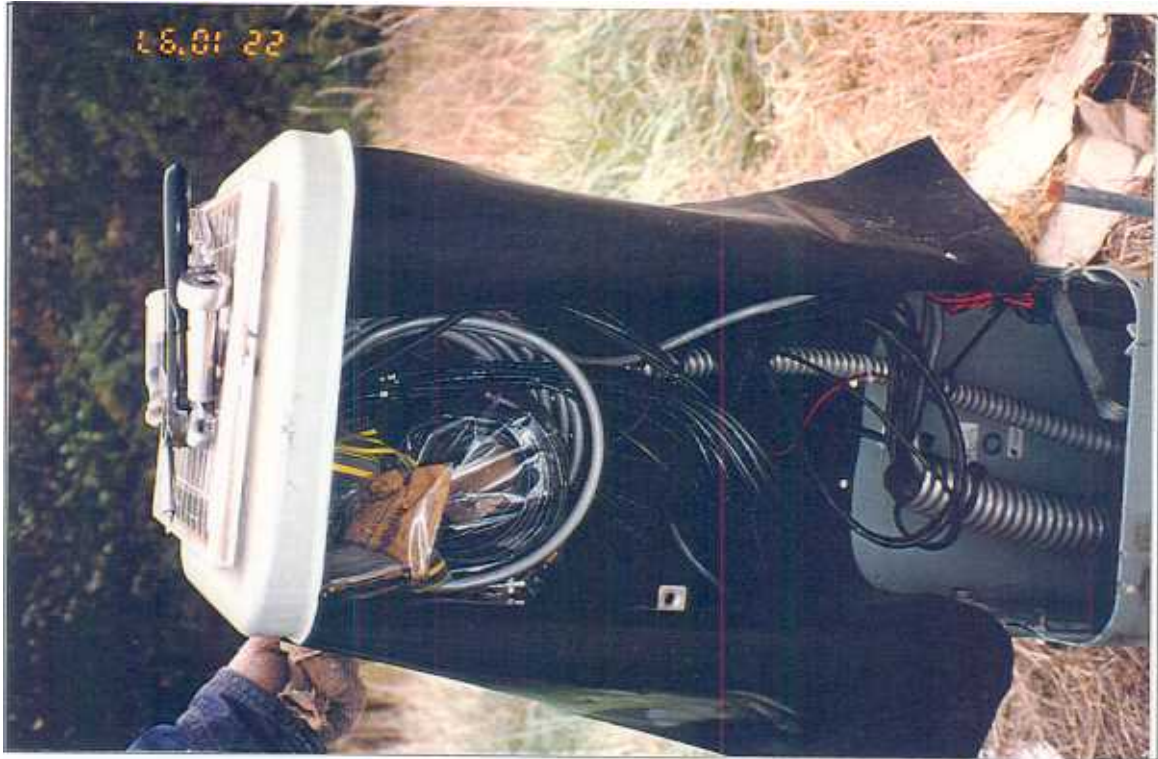
**Inside Equipment Cabinet, Seasonal Site 331001 - Oct. 1997, after Suspension Activities**

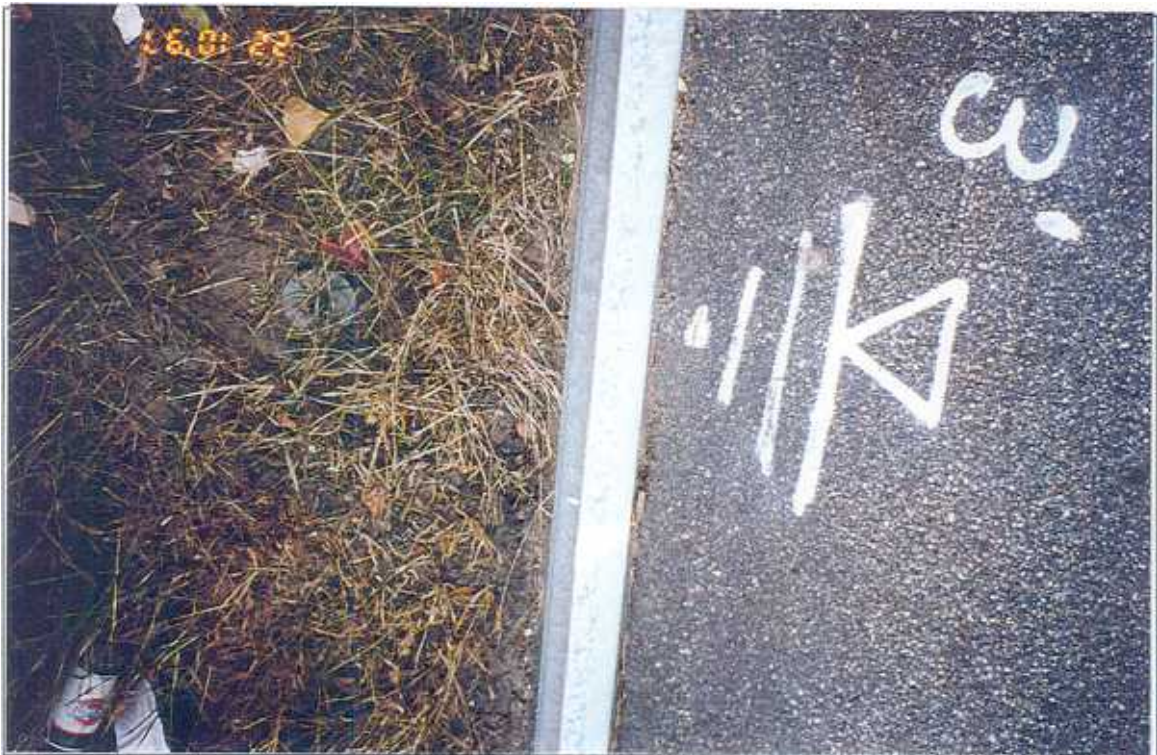
**Piezometer with identifying paint markings, Seasonal Site 331001 - Oct. 1997, during Suspension Activities**
